**HIGHLAND FLATS TREE FARM**  
**WETLAND AND RIPARIAN MITIGATION**  
**-2018 ANNUAL REPORT-**

**December 2018**

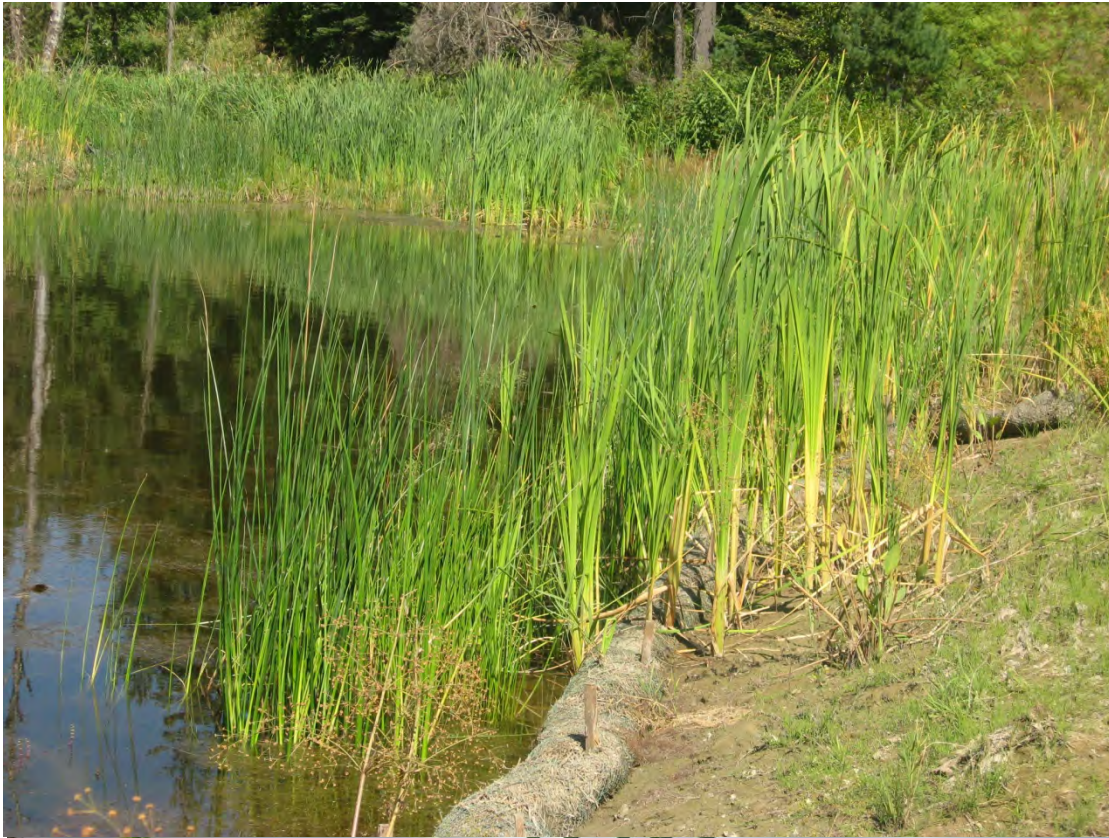
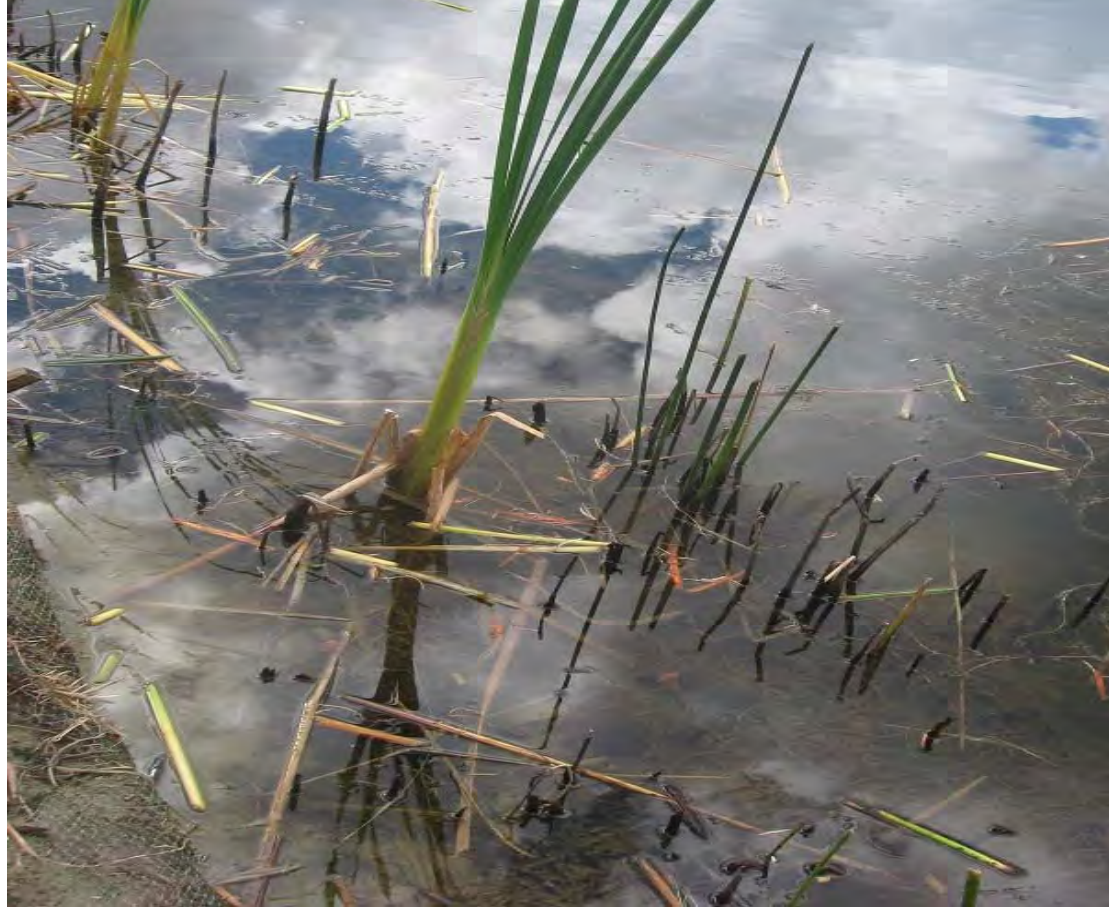
**Issue:** Bulrush sod cover declined substantially in midsummer after early vigorous June growth was observed. Waterfowl herbivory appeared to be the primary cause, particularly between the end of June and the end of July. However, high early spring reservoir water levels may have also affected the bulrush. Figure 2 compares the Upper Reservoir growing season water levels from the time of staff gage installation in July 2016 to September 2018.

**Figure C-13. Bulrush sod patch in Fall 2017 (top) and a close-up of the same patch in Fall 2018 (bottom) depicting waterfowl herbivory.**

**Actions Taken:** No waterfowl remained on the reservoir in July. To help promote growth on the damaged stems, approximately 1,000 gallons of water were immediately removed from the reservoir to lower the water level and expose all shoots, with an ongoing program to remove 500 gallons/week until the upper gage water level dropped to less than 2.0 feet.

**Recommended Actions:** It is possible that the bulrush may recover from the waterfowl damage, or that other native plants may expand into the deep marsh if no additional damage occurs. The need for remedial planting should be re-assessed in early 2019 to allow the potential for bulrush recovery to occur. The following steps are recommended:

- (2) If water levels remain high, begin to draw the water down to reach a level of less than 3.3 feet at the upper gage by early May, with subsequent drawdowns of 0.1 feet/week (or as prescribed by the Wetland Scientist for exact May site conditions). Use this water for the HW irrigation.
